Educational Buildings Occasional Paper No. 8

# Multi-Purpose Buildings for Disaster Situations in Thailand

Report prepared by  
*Mr. Kriangsak Charanyanond*, Architect

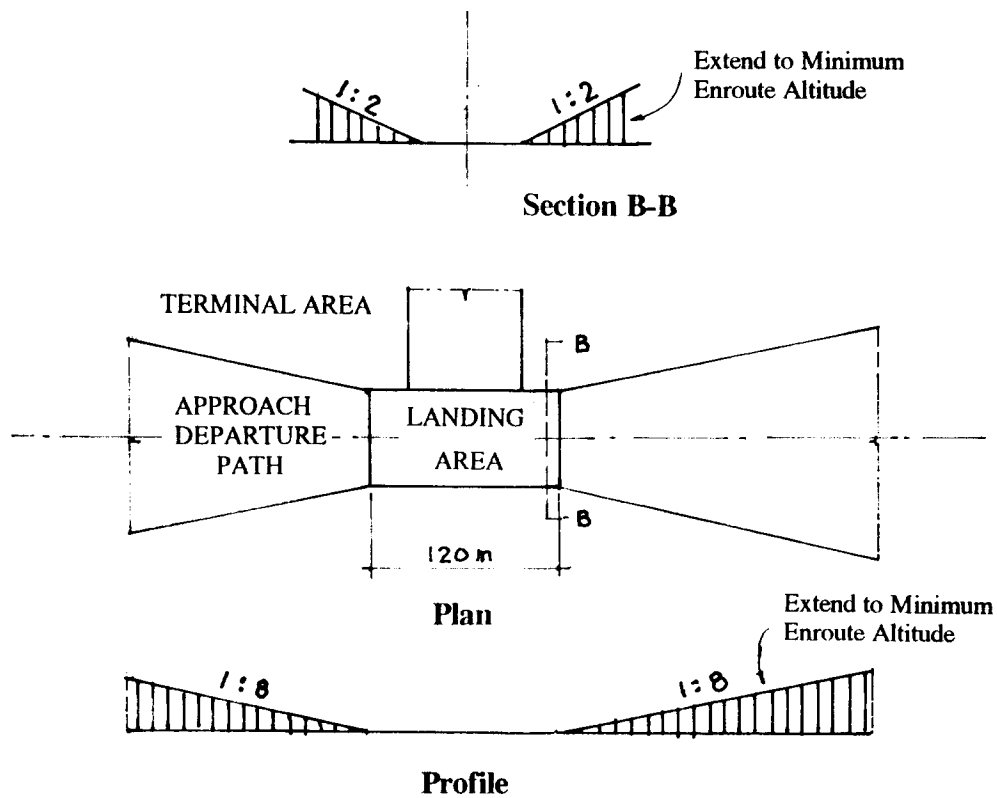
Figure 2. FAA Recommendations for approach departure obstruction clearance
